CONCISE REPORT

Can the use of assistive technology and interactive therapeutic robots in nursing homes contribute to the spread of infectious disease?

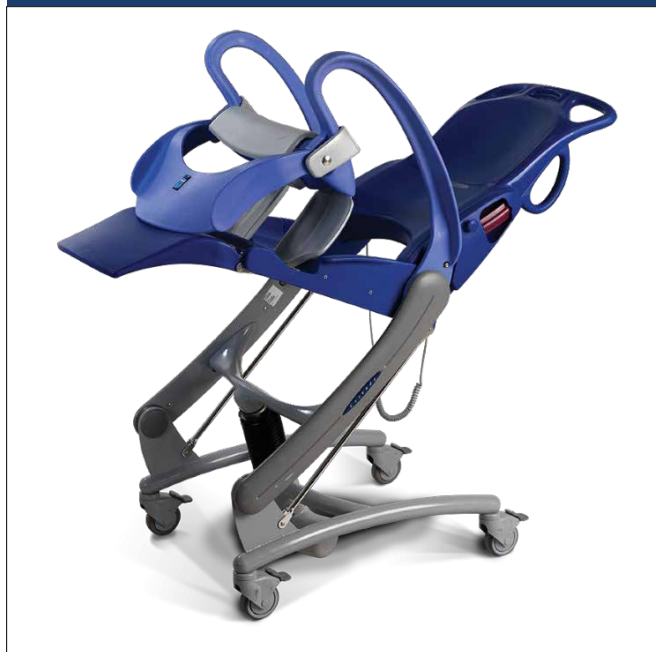
FIGURE 1: Multipurpose hygiene chair Carendo, ArjoHuntleigh [from: <http://www.arjohuntleigh.com/products/hygiene-systems/showering/shower-chairs/carendo/>]

Multipurpose hygiene chairs are used for washing and cleaning routines that require assistance from nursing staff (Figure 1).

Four hygiene chairs (Carendo, ArjoHuntleigh, Sweden), two in each nursing home, were labeled according to the following scheme NxCx (N for nursing home 1 or 2, C for chair 1 or 2). N1C1 was not in use, due to necessary maintenance, but served as reference. N2C2 had been used by one resident only. N1C2 and N2C1 were in use by more than one resident, and no special precautions other than visible cleaning have been done. All hygiene chairs were visible clean according to applied standards [3] before sampling.

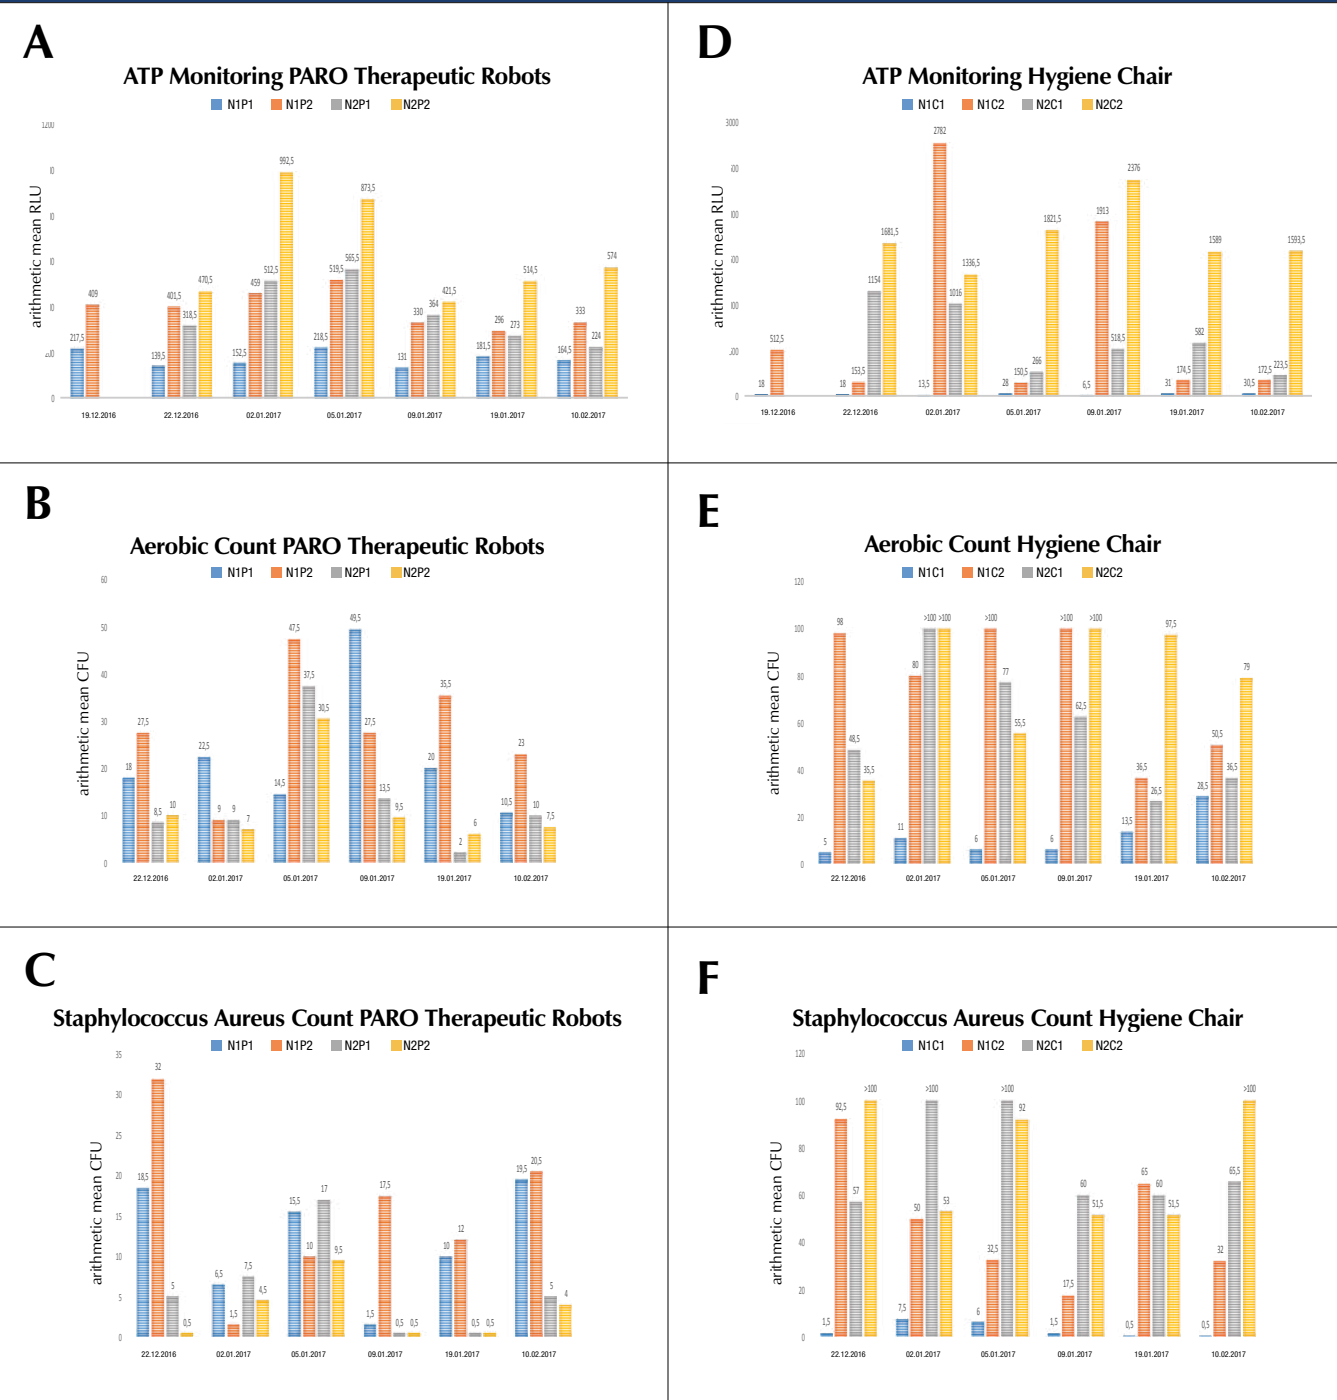
FIGURE 3: Serial measurements (mean values) of ATP (a,d), aerobic counts (b,e) and *Staphylococcus aureus* counts (c,f) for PARO robots (a,b,c) and hygiene chairs (d,e,f).

PARO robots N1P1 and N1P2 were not in daily use, which could explain the lower arithmetic mean relative light units (RLU) values, i.e., luciferase activity, compared to the frequently used N2P1 and N2P2 (Figure 3, a). By contrast, N1P1 and N1P2 gave higher arithmetic mean CFU for both aerobic (Fig. 3, b) and *Staphylococcus aureus* counts (Fig. 3, c).

The hygiene chair N1C1 was not in use at the time of testing which may explain the results of the ATP monitoring. However the aerobic count had an arithmetic mean CFU/ml up to 28.5 (Fig. 3). All other Hygiene chairs were sampled after standard cleaning. These showed both a high aerobic count (Fig. 3, e), as well as a higher degree of contamination with *Staphylococcus aureus* (Fig. 3, f). Furthermore, the ATP monitoring (Fig. 3, d) revealed that biological contamination in nursing home two was higher overall than in nursing home one. One Rida®Count sampling of N2C1 gave typical colonies for MRSA on the MRSASelect™ agar. The latter was, however, not validated by other methods. Coliform bacteria (Table 1) were found on all four robots. N1P1 tested positive for *Enterobacteriaceae* at one sampling (Table 1, N1P1).

PARO robots are often used by several residents and shared between different nursing home sections. It is difficult to clean the artificial fur; it can only be removed and washed by the distributor. However, based on ATP monitoring and aerobic count (Fig. 3, a and b) it seems that bacteria do not long remain viable on the PARO. Nevertheless, it seems also that the PARO robot may be a beneficial environment for *Staphylococcus aureus* (Fig. 3, c). Further studies are needed to confirm this.
